# Manhole Inspection Summary

Manhole # S41C\_\_037MH

Insp Date: **2/2/09 10:00 AM**

**Location** Address: **orleans st**

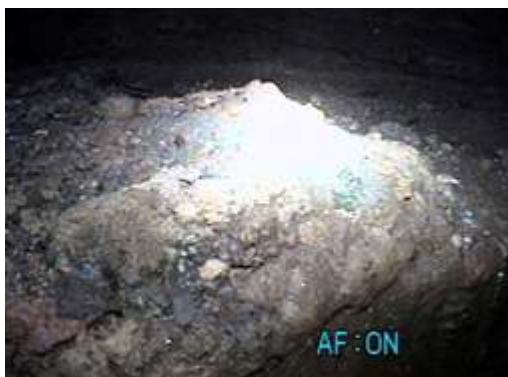
Defect 2

**Bench** ☒ Exists Material: **Brick** ☐ Parged

Condition: ☐ Sound ☐ Cracked ☐ Root Intrusion ☐ Deteriorated ☐ Leaks ☒ **Debris**

bench debris

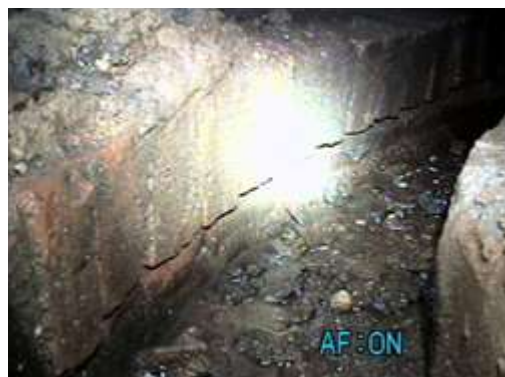
Defect 1

**Channel** Material: **Brick** ☐ Parged

Condition: ☐ Sound ☐ Cracked ☐ Root Intrusion ☐ Deteriorated ☐ Leaks ☒ **Debris**

channel debris

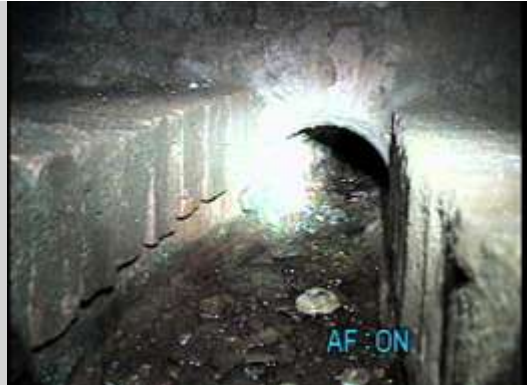
12 O'Clock Outflow

8 in. Circular Gravity Sewer  
Pipe Out @ 12 O'Clock

Pipe Material: **Clay** ☐ Pipe Lined

Invert Depth: **5.13** (ft.) Flow Characteristics: **None**

Deposits: ☒ None ☐ Mud ☐ Sludge ☐ Debris ☐ Grease

Infiltration: **None**

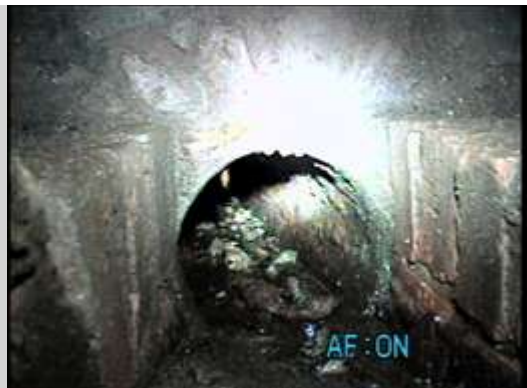
3 O'Clock Inflow

8 in. Circular Gravity Sewer  
Pipe In @ 3 O'Clock

Pipe Material: **Clay** ☐ Pipe Lined

Invert Depth: **5.10** (ft.) Flow Characteristics: **None**

Deposits: ☒ None ☐ Mud ☐ Sludge ☐ Debris ☐ Grease

Infiltration: **None**
